## A Comparative Analysis (SWOT) of Technical Intervention Plans Carried Out in Sistani House and Payambar Mosque of Bam Citadel

**Keywords:** Bam Citadel, Payambar Mosque, Sistani House, Intervention Plan, SWOT Analysis

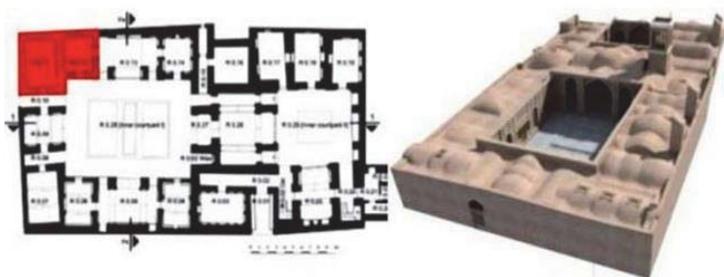
Figure 1. Plan and 3D view from Sistani House of Bam Citadel

The Sistani House as one of the noblest mansions of Bam Citadel is located in the middle of the citadel. It probably belonged to the Sistani family during the Zand period (1750-1794 AD) (Bam3DCG, 2016). This single storey building occupies an area about 673 m<sup>2</sup> (Khakzad, 2011). Access to Sistani House is possible by the main entrance door located almost in the middle of house's western wall. It consists of two independent courtyards in the east and west, which are bordered with "winter rooms" in the north and "summer rooms" in the south. The western courtyard with eleven rooms in its sides was larger than eastern courtyard with four rooms, and access between two courtyards was possible with a low corridor. Because of the security reasons, there were no windows in the outer walls. The characteristic elements of this property were its four-sided windrowers as traditional air-conditioning system.

Main Original Materials and Construction Techniques: Adobe-mud brick construction technique	
Architectural elements	Niches, Heater, Under walled arches, Decorative latticework by wood and adobe in openings, Windrowers, Central courtyard and Pool.
The Type of Roofs	Different types of barrel, Dominical and Trought vaults.
Surface Coating Material	Gypsum decoration, Chalk trim, Mud and Sieved Straw and Mud and Straw Plaster.

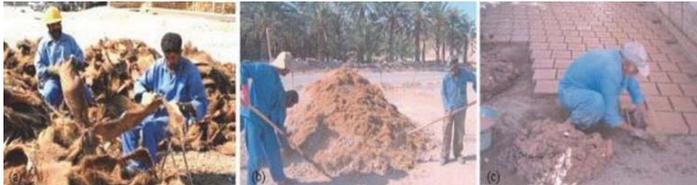
**Figure 2.** Process of the production of reinforced adobes with palm fiber in Bam Citadel workshop  
**Source:** archive of RPBCH, 2008

(II) Production of reinforced adobe bricks by palm fibers: any new approach in Sistani House had to start from enhancing the capability of adobe building to react flexibly to seismic motion without the immediate loss of coherence. The team of the Technical University of Dresden conducted a wide range of practical tests for improvement of mechanical property of adobe bricks in the laboratories of the Dresden University as well Bam to find best additive material. After running a test row on different materials, it was decided to propose "palm fibers" as suitable material for reinforcing of adobe bricks. Tests have proved a considerable increase in compression and tensile strength of reinforced adobe bricks. The palm fibers have the additional advantage of abundant local availability; palm fibers are a side product of the

extended date growing gardens as the material is normally simply burned. In this way to prepare palm fibers as additive material to adobe mortar, the thick edge of palm leaves were separated and then the remained softer leaves were cleaned. In the next step, they were cut out to smaller parts for putting inside of machine designed for chopping of palm leaves. Afterwards, the palm fibers were mixed with other ingredients. As mentioned by Jäger & Fuchs (2008) about the rate of materials' combination, "The results enabled us to name the exact quota of the ingredients clay and sand (70: 30) and fibers (0.6% of the weight of the sand-soil compound)." In this case, according to the statistics presented by RPBCH, over 25000 reinforced adobe bricks with palm fibers for being used in reconstruction operations of Sistani House were produced in Bam Citadel's workshop.

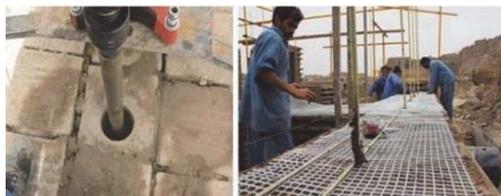
**Figure 3.** (Left) drilling of adobe wall for insertion of fiberglass rods; and (Right) placement of fiberglass mesh on the wall  
(Source: archive of RPBCH, 2008).

(V) Reinforcement of walls vertically: at first, for the reinforcement of walls in Sistani House, fiberglass rods had to be inserted vertically. To this end, scaffolding was installed alongside the walls upon which the core-drilling machine for the vertical boreholes was mounted. These were drilled in an interval of about 100 cm with a width of 10 cm, which reached down to depth of 1.5 m below ground level. The vertical anchors consisted of three glass fiber rods with a diameter of 8 mm. On their lower end, the bundle of three rods was spliced up; it was inserted into a block of fine concrete that tied the vertical anchor to the ground. The rest of the borehole was filled with the same clay suspension that was used for the grouting in the consolidation phase. The vertical anchors reach up to the highest parts of the walls (Jäger and Fuchs, 2008).

(VI) Reinforcement of walls horizontally: in this case, every 0.50 m in height, a layer of fiberglass mesh was inserted into the horizontal joint in the masonry. In addition to that, a horizontal rod of fiberglass was fixed to the vertical anchors (Jäger and Fuchs, 2008).

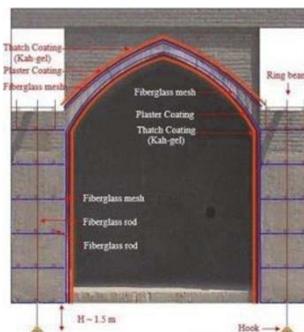
**Figure 5.** Schematic view from intervention plan implemented in the Sistani House of Bam Citadel (Designed by Author).

As part of the international efforts for reconstruction of some of the key properties of Bam Citadel, the Dresden Technical University of Germany together with Jaeger Consulting Engineers Ltd. contributed in a comprehensive research, restoration and reconstruction plan of the Sistani House. In order to develop a strengthening methodology for Sistani House, two rooms in the northwest corner have been chosen as a pilot project. The central idea of the proposed measures was to find a sensitive balance between the demands of an earthen world cultural heritage site as well as the demands of modern retrofitting techniques preventing in an area of strong seismic activity with the aim to create an earthquake resistant building technology. This project was the result of the conceptual design and the consideration of the pros and cons of the different variants for dealing with the remains (Jäger, Fuchs, and et al., 2007). At first step towards complete rehabilitation of the Sistani House, the project started in the second half of 2006 with material tests for retrofitting technologies which had to guarantee that the buildings will not collapse once more during the next possible earthquake of the same intensity. Therefore, German group began its actual work on the property in the summer of 2007 and finished it in April 2008. Now the work is ongoing by the same method with Iranian experts from RPBCH. The following steps listed below are measures which have been implemented in Sistani House through intervention plan proposed by Dresden University of Germany:

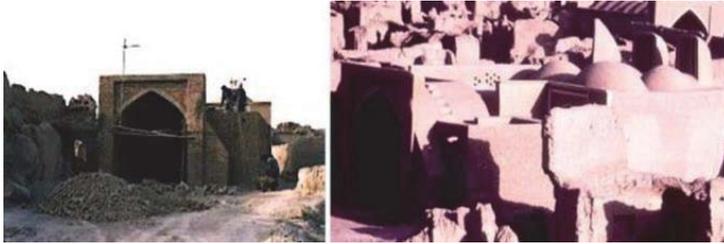
**Figure 7.** (Left) restoration activities in Payambar Mosque of Bam Citadel (Source: archive of the RPBCH, 1990); and (Right) view from Payambar Mosque before earthquake (photo by Louyot, 2003)

There is no precise report regarding the previous conservation activities of the Payambar Mosque before the earthquake. In this case, I have just found a picture that shows the intervention works in process in 1990. The Payambar Mosque was severely destroyed during the 2003 earthquake. Through the earthquake, this monument sustained damages more than the other buildings; all the western and northern parts of the property were fully destructed. The central column of the Mosque, which suffered all of loads transferred by four domed shape roofs could withstand by cracks in its lower part, but the domes were completely shattered.

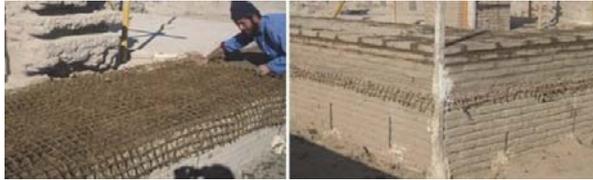
**Figure 7.** The process of Palm mesh insertion between layers of adobe-wall in Payambar Mosque (Source: RPBCH, 2008).

(III) Reinforcement of walls vertically: to provide any required bending resistance in the monument, the structure was connected to the ground with some innovative method by embedding local tension elements "palm fibers". The figure 8 exactly shows the details of drilling procedures by halter for inserting vertical elements to the foundation soils at depths of 150cm. In this case, vertical elements were installed along a certain line by maximum distance of around 110cm that is reduced to 60cm in the compulsory points at the center of main walls.

(IV) Reinforcement of walls horizontally: on the other hand, to provide shear resistance in the structure, the natural horizontal elements produced by local producers "palm mesh" was to be inserted as tension elements from within thickness, by going towards upper parts of the wall, the palm meshes used between brick lines were decreased (figure 7). Meanwhile, to install natural fibers between rows of adobe bricks, a simple tool was used to stretch the meshes during their operation.

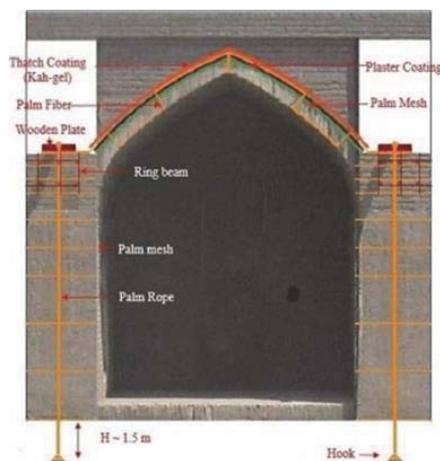
**Figure 8.** Schematic view from intervention plan implemented in the Payambar Mosque of Bam Citadel (Designed by Author).

The intervention plan of Payambar Mosque that was proposed by Iranian experts from RPBCH can be known as the best example for simultaneous use of engineering restoration outcome and traditional restoration knowledge. The central focus on intervention plan of Payambar Mosque was inspired from experiences acquired from previous intervention pilot projects in other monuments of Bam Citadel, such as Tekiyeh, Bazaar, Sistani House and Barrack. So far, a special attention has been dedicated to traditional methods by using local materials (palm fibers and palm meshes). The concern in this technique was the seismic loads of the dominant force for destruction of adobe-mud brick properties that would be reduced. During reconstruction phase, to keep the authenticity and integrity of the property, the damaged parts of the mosque had been reconstructed based on the original location of the walls extracted from available documents and ruins remained after the earthquake. The following steps listed below are measures which have been implemented in Payambar Mosque through intervention plan proposed by Iranian group:
